STATE OF IOWA
DEPARTMENT OF COMMERCE
UTILITIES BOARD

IN RE: MIDAMERICAN ENERGY COMPANY	DOCKET NO. PSA-07-1 (WRU-06-35-156)
--	--

**ORDER DIRECTING RESPONSE TO STAFF REPORT
AND TAKING OFFICIAL NOTICE**

(Issued June 4, 2007)

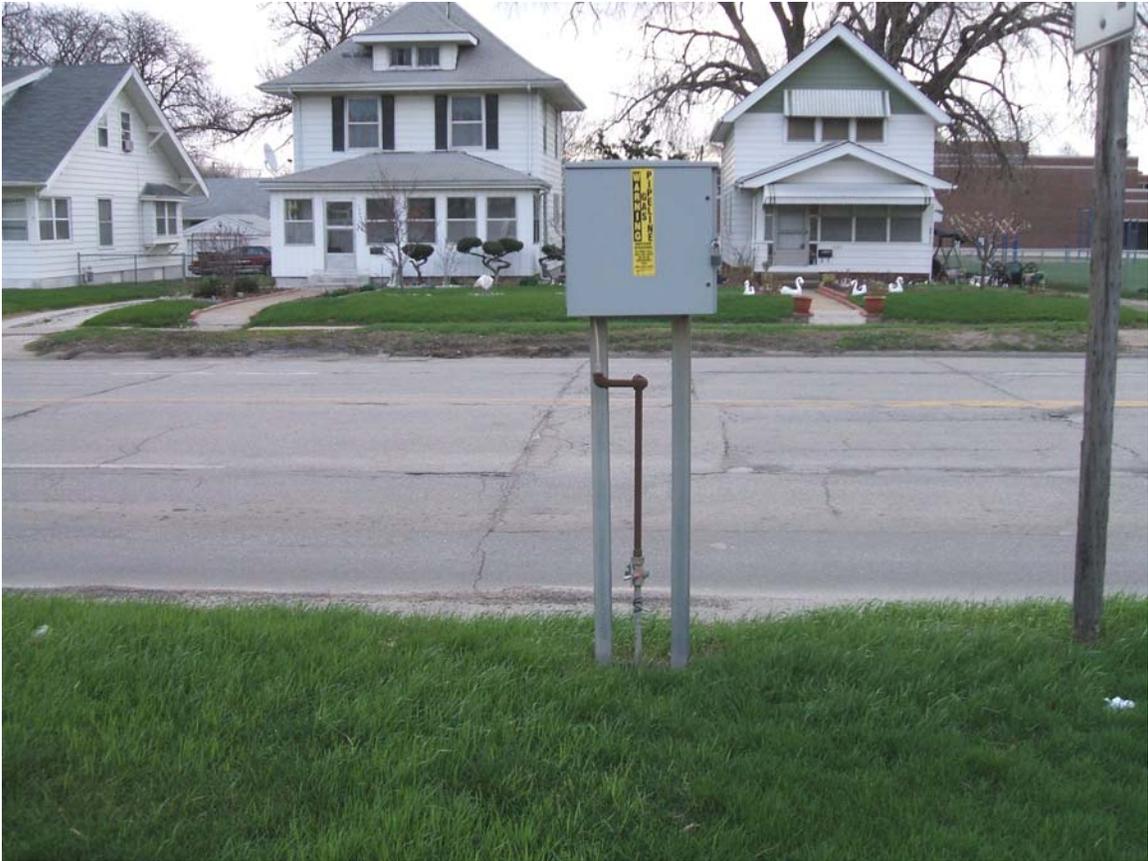
PHOTO # 1

The 1990s design is shown in Photo # 1. In that design MEC used two steel I-beams with the pressure recorder mounted between them. The Anodeless gas riser was also installed between the I-beams. MEC used rigid schedule 40 screwed pipe to attach the riser to the pressure recorder. The current design, shown in Photo # 2 shows the pressure recorder mounted on a 2-inch galvanized pipe. Both the galvanized pipe and the anodeless riser are located in a concrete pad at the base of the recorder. The pressure recorder is connected to the anodeless riser using 3/8-inch stainless steel tubing.

East 14th Street North of University Des Moines

This is the 1996 pressure recorder design.

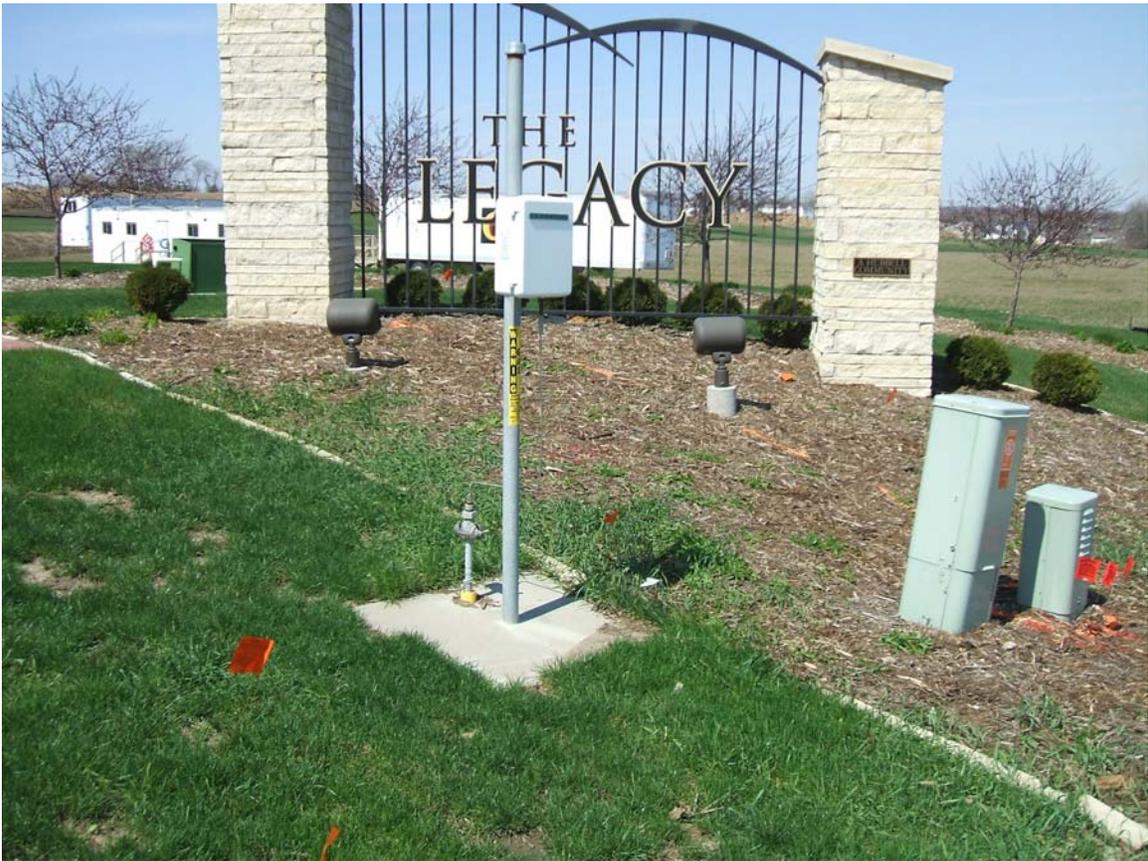
PHOTO # 2

Colonial Parkway and Highway 28 Norwalk

This is MEC's new pressure record design.

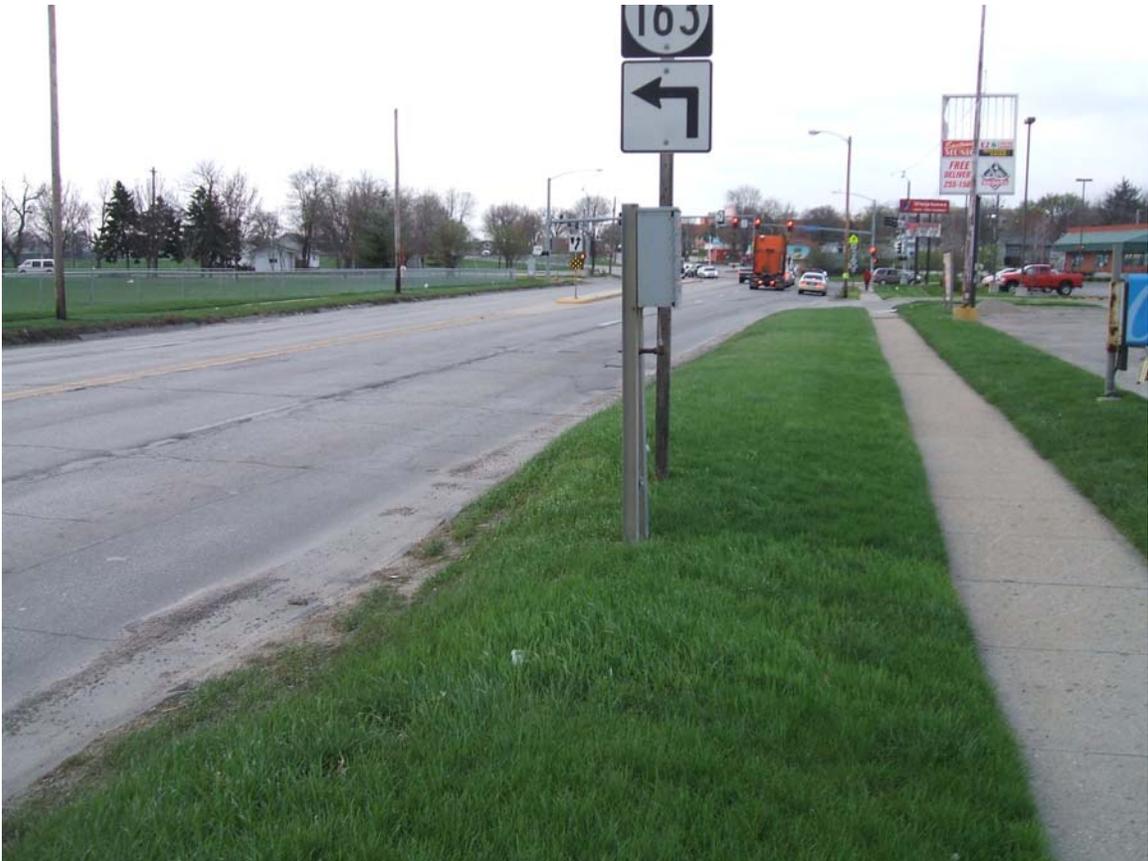
PHOTO # 3

1. Two locations were found where pressure recorders were installed close to a busy roadway, placing them at risk of vehicular damage. 49 CFR Part 192.317(b) states: *Each aboveground transmission line or main, not located offshore or in inland navigable water areas, must be protected from accidental damage by vehicular traffic or other similar caused, either by being placed at a safe distance from the traffic or by installing barricades.* Photos # 3 at East 14th Street north of University, Des Moines and Photo # 4 at SE 14th Street and McKinley Ave. Des Moines show facilities installed close to a busy highway, requiring additional protection from vehicular damage.

East 14th Street North of University Des Moines

This installation is subject to vehicular damage.

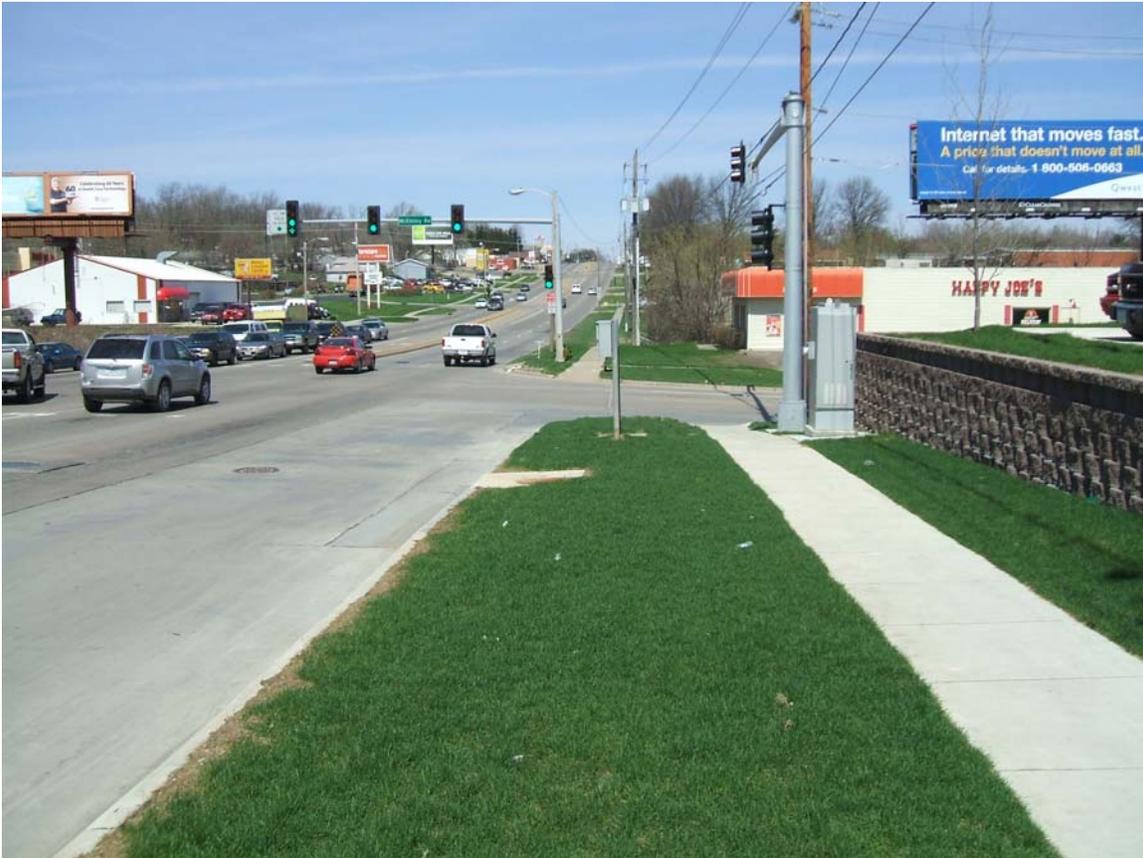
PHOTO # 4

SE 14th Street and McKinley Ave. Des Moines

This installation is subject to vehicular damage.

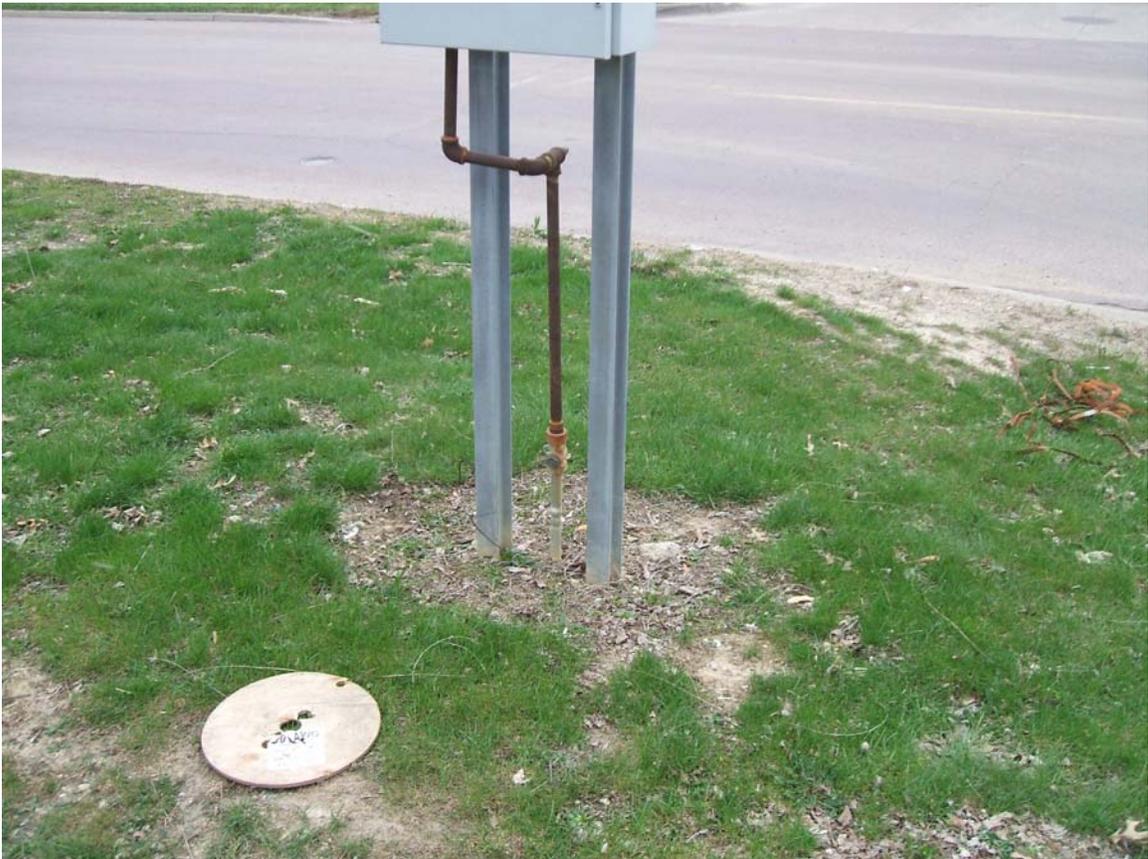
PHOTO # 5

2. The 17 pressure recorders installed in 1996 used schedule 40 screwed pipe to attach the pressure recorder to the anodeless riser. At each of those locations Board staff found the pipe was corroded. 49 CFR Part 192.479 and .481 require the operator to monitor aboveground piping for atmospheric corrosion and take corrective action when corrosion is found. Photo # 5 is an example representative of such locations.

East 29th Street and Ovid (Goodrell School) Des Moines

This installation shows atmospheric corrosion on the schedule 40 pipe from the Anodeless riser to the pressure recording gauge.

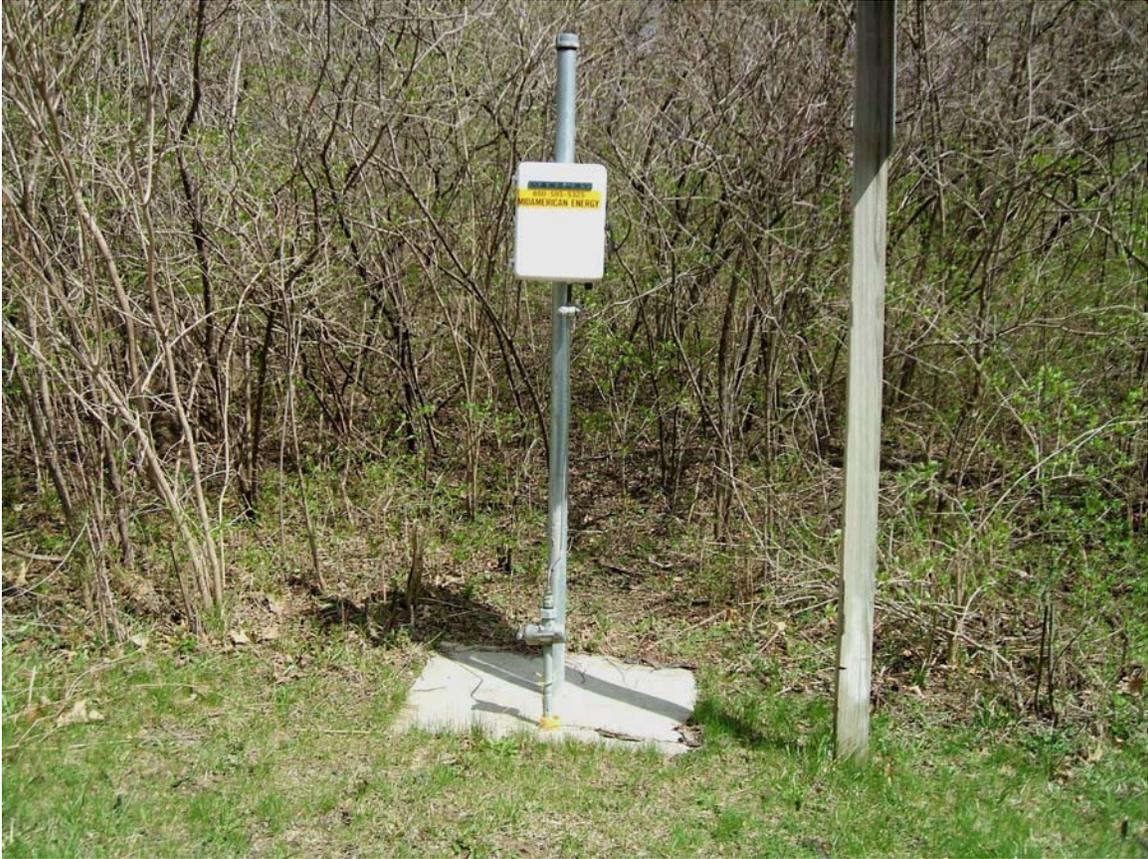
PHOTO # 6

3. MidAmerican Energy Company's Operations and Maintenance Plan Section G 60.20 requires pipeline markers be placed on all aboveground piping that is accessible to the public. During Board staff's investigation, staff found 10 pressure recorder locations where either the pipeline marker was missing or where only partial information was listed. This is a Probable Violation of 49 CFR Part 192.707(c) and .13(c). Photos # 6 through # 9 show both new and old locations where markers were missing.
4. At two specific locations, Board staff noted that the stainless steel tubing used between the pressure record and the Anodeless risers were subject to damage by the public. Those locations are shown in Photos #8 and # 9. MEC needs to take additional action to protect those lines for damage by the public.

NW School and West 1st Street Ankeny

This photo shows a lack of warning information on the recorder.

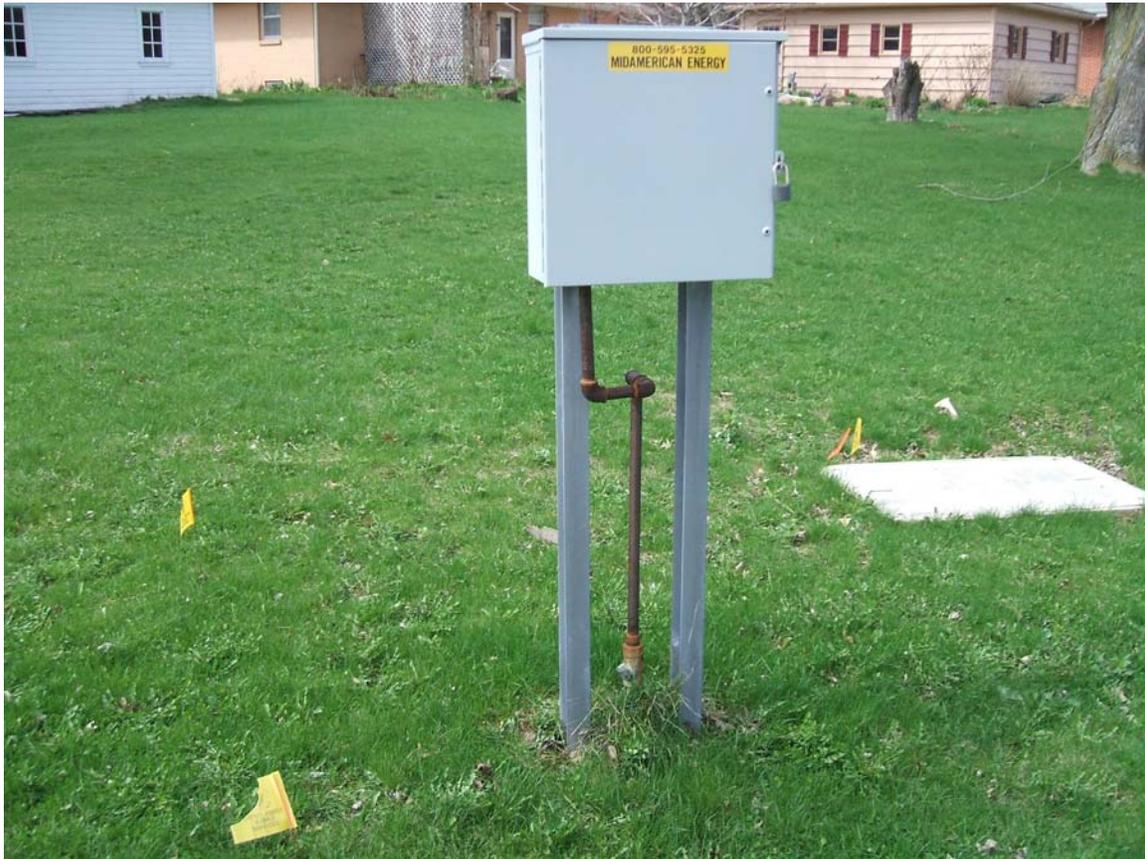
PHOTO # 7

Grand and Vine Streets West Des Moines

This photo shows a lack of warning information on the recorder and atmospheric corrosion on the schedule 40 pipe from the Anodeless riser to the pressure recording gauge.

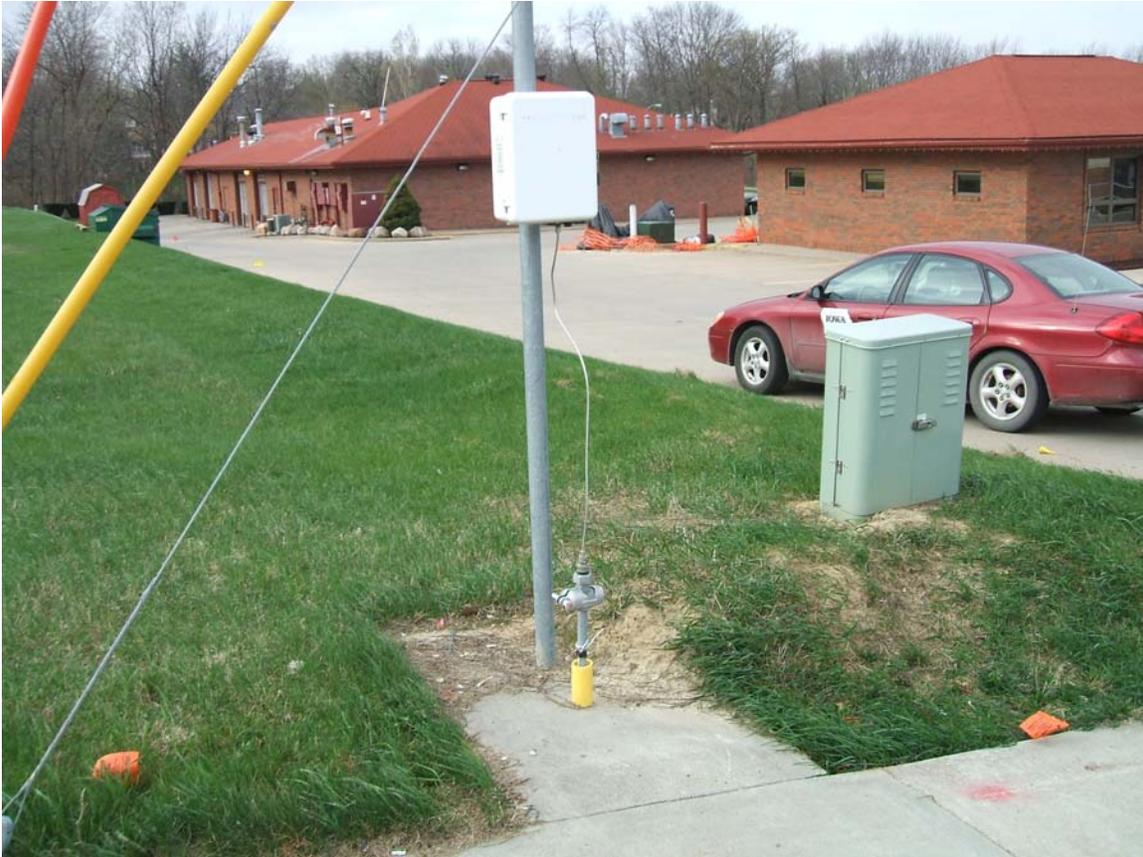
PHOTO # 8

Maple Drive East of Hickory Blvd. Pleasant Hill

Missing Pipeline Marker and Stainless Steel Tubing subject to damage by the public.

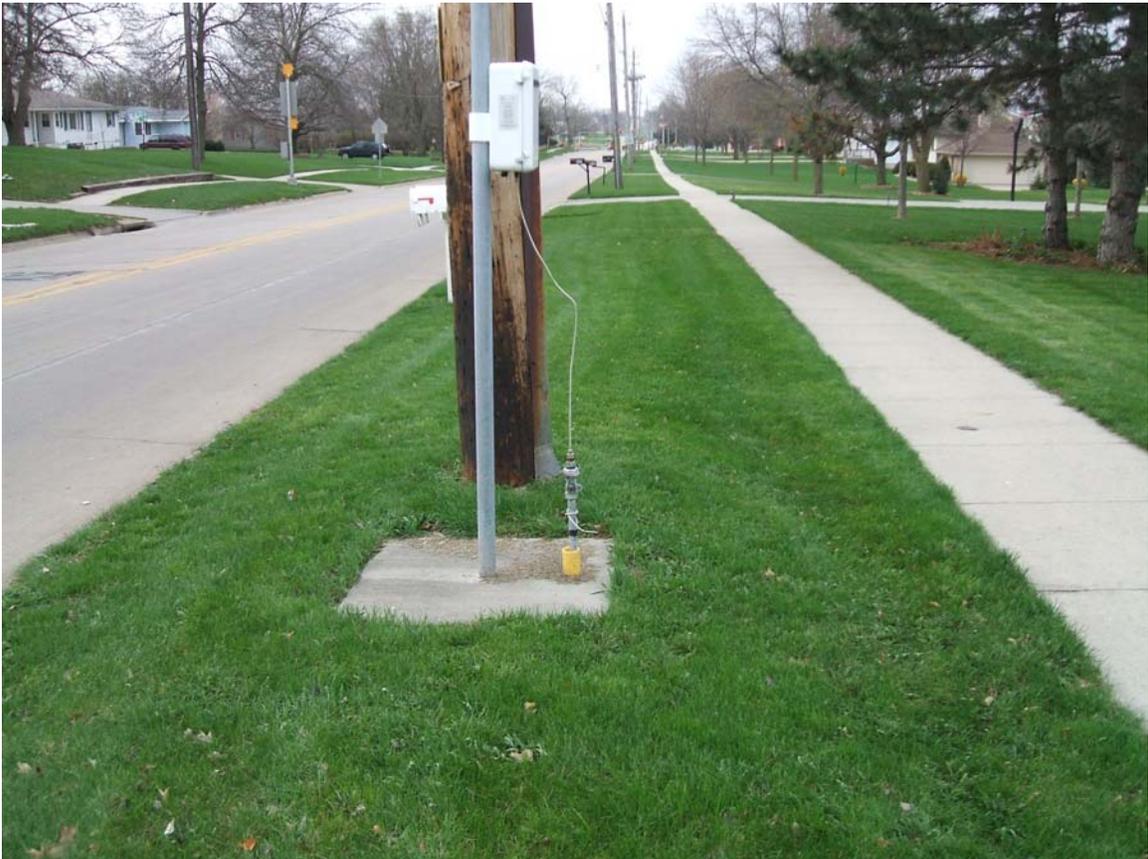
PHOTO # 9

410 SW 17th Ave. Altoona

Missing Pipeline Marker and Stainless Steel Tubing subject to damage by the public.
